DLCO measurement with EasyOne Pro

“Leaks” in breath hold position.

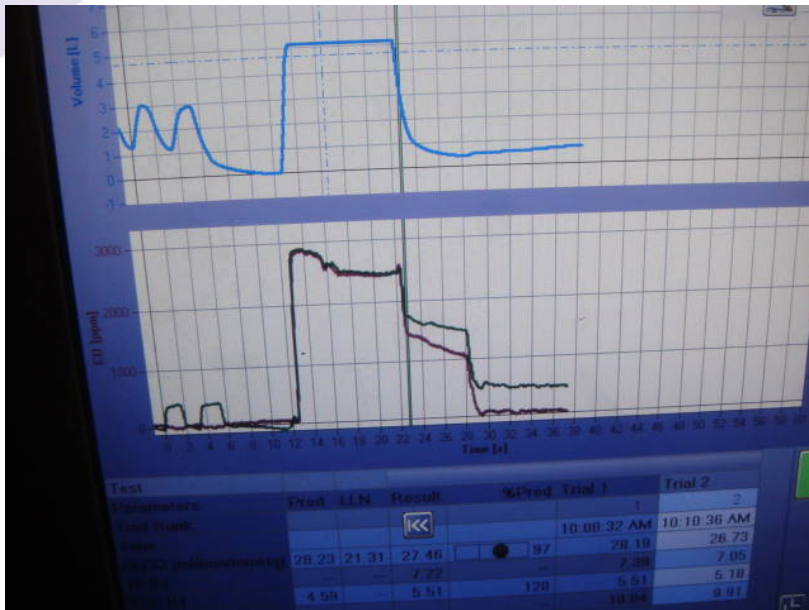
Effect:

Cause:

Small leaks in the overflow valves

Likely cause maybe dust particles stuck between membrane and valve seat.

Ask the patient to give a little exhale pressure during breathhold “against the valve; just a touch of course, then the plateau will be maintained, this example shows a patient with a tiny under / overpressure and the effect on the “leak” induced pattern

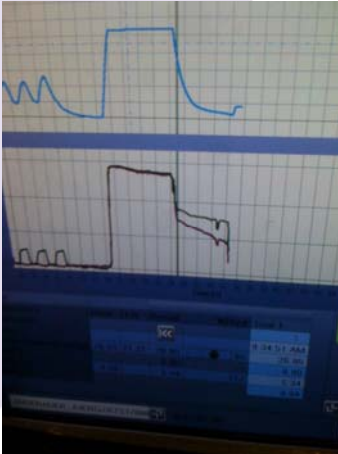
This example shows a patient pushing a little bit from the onset of breath hold time (i.e. not to let the leak become effective.)

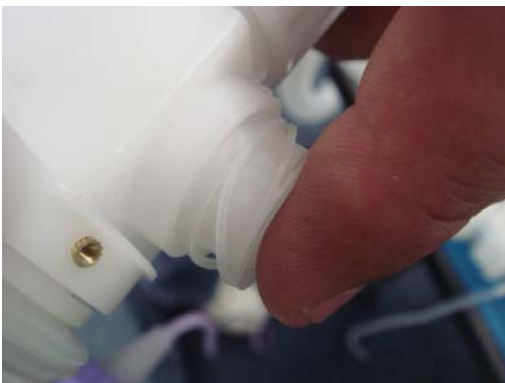
Cleaning of the overflow valve seat and membrane:

Remove the valve protection and carefully move the membrane with great care such as to remove dust particle, you may

- Lift the membrane
- Blow with a rubber balloon
- Move the membrane on the seat by slight finger pressure (see above)

Then reposition the valve protection

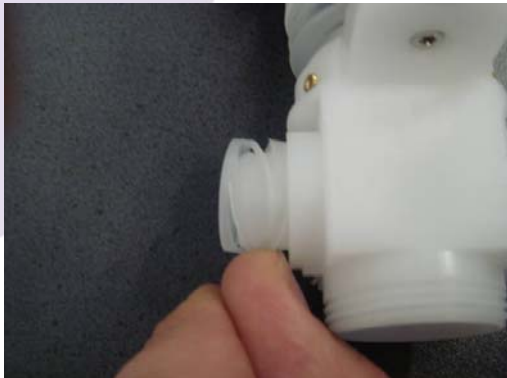
In case of damage to the valve seat:

You may remove the fragile membrane by pushing the retainer ring slowly and carefully. **NEVER** pull on the membrane
